Analysis of the Decline of Concrete Structure Durability of a Seaside Gymnasium

Abstract. To investigate the causes of the decline of concrete structure durability of a seaside gymnasium, we conducted durability tests at representative areas of the building based on the inspection of its appearance. The tests included the examination of rebar position, thickness of the concrete protection layer and concrete neutrality. The test data is analyzed based on both the original structure design and the construction report. Results show that the main causes of the decline of concrete structure durability include neutralization of concrete and shifting, lack of thickness and water seepage of the protection layer due to construction defect. The durability problems of seaside concrete structure are not necessarily caused by chloride ion invasion.

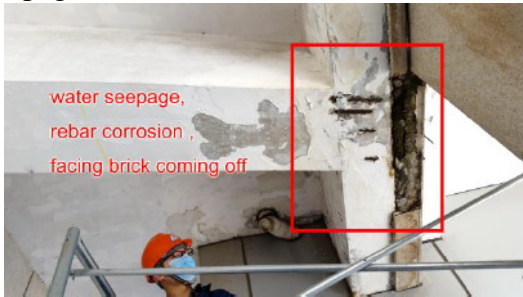
Figure 1. Water seepage, rebar corrosion.

After the appearance investigating, we found many problems: water seepage, rebar corrosion, cracking, concrete spalling and coming off of facing brick (Figure 1). Most of these problems appeared on the periphery of top slab of 1st floor, around the support columns and the drain pipe. Water seepage also appeared at the bottom of expansion joints and these areas usually were accompanied by corrosion of rebar. There were several area, in which rebar was almost exposed and could be taken down by hand (Figure 2). Preliminary measurement showed that the corrosion part had taken over 1/3 of the diameter of the rebar

Even though the top slab of 1st floor had drain channel and pipe, along the edge of the top slab rainwater still collected. In addition, expansion joints were damaged and this caused water seepage.

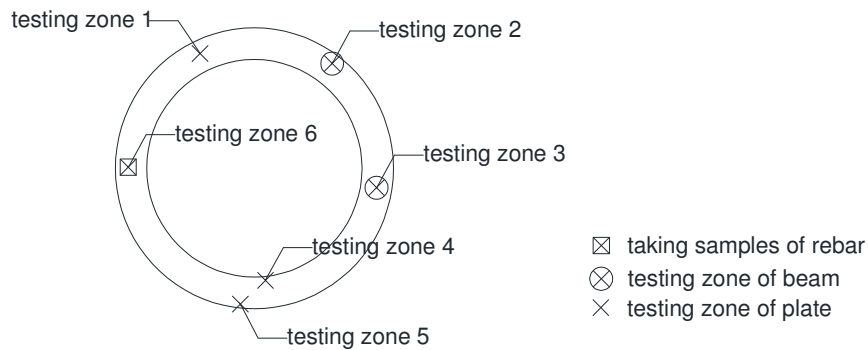
Figure 4. Sketch of testing zones.

After the appearance investigation of the gymnasium, in different directions of the building we selected 5 testing zones and 1 zone to take samples of exposed rebar (Figure 4). special testing for durability would be conducted in each of the zones. The size of testing zones of plate was about 80cm×80cm, the length of testing zones of beam was about 80cm and the width was the same with the beam. In 4 of the testing zones, the rebar was rusted and exposed, measurement of thickness of concrete cover would be easier. In 1 of the testing zone, iron mold was obvious, but the rebar was not exposed.

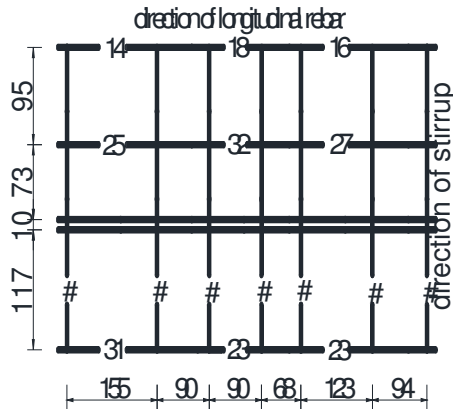
According to the testing results, draw figure to show thickness of concrete cover in some of the testing zones(Figure 5, Figure 6) and analyze the test result of all the testing zones(Table 1).

Figure 5. Rebar location and thickness of concrete cover in testing zone 3 [mm]("#" represent thickness of concrete cover less than 12).

According to Table 1, in all zones, average of thickness of measurement is less than thickness of design, in some zones the rebar is even exposed. According to the measurement, location of rebar was irregular, the distance and angle of rebar of measurement was very different from the value of design. The coefficient variation and standard deviation is relatively small, indicating that the thickness of concrete cover is even.

(3) The distance between rebar was different from design value. In some testing zone, we found that the rebar cage was rough, some rebar distance of measurement was only 10 mm (Figure 9), however, the design value was 150 mm. Even though the rebar cage was level, incorrect positioning of rebar made concrete cover of some rebar too thin. Taking testing zone 3 as an example, some rebar nearly adjoined each other, and the location of some rebar was very

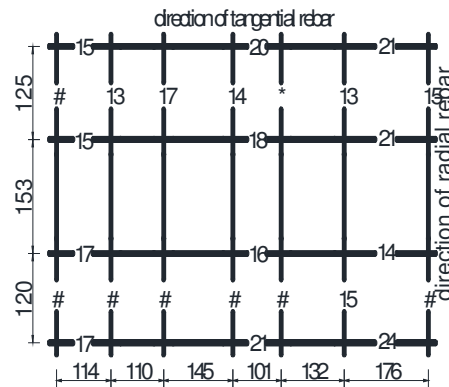
Figure 6. Rebar location and thickness of concrete cover in testing zone 5 [mm]("#" represent thickness of concrete cover less than 12, "*" represent the exposed rebar).

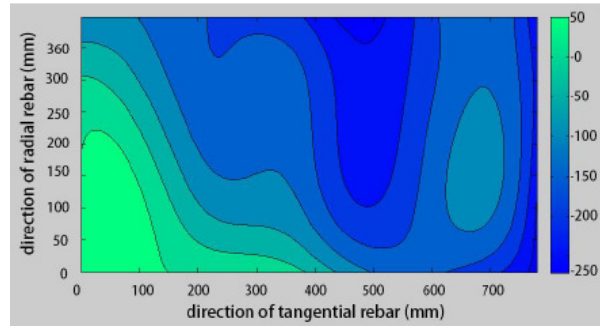
Using Elecometer331 and Cu-CuSO₄ electrode, we measured the potential on surface of concrete by half-cell potential method. According to the figure, there was obvious minus value. According to *Technical standard for inspection of building structure* (GB 50344-2004), the absolute value of minus value is larger, the more likely that the rebar under the surface is rusted. Take testing zones 4 and 5 as example (Figure 5 Figure 6), they confirmed that the potential of concrete in area of iron mold was lower than other area.

Figure 6. Potential on surface of concrete in testing zone 5 [mV].

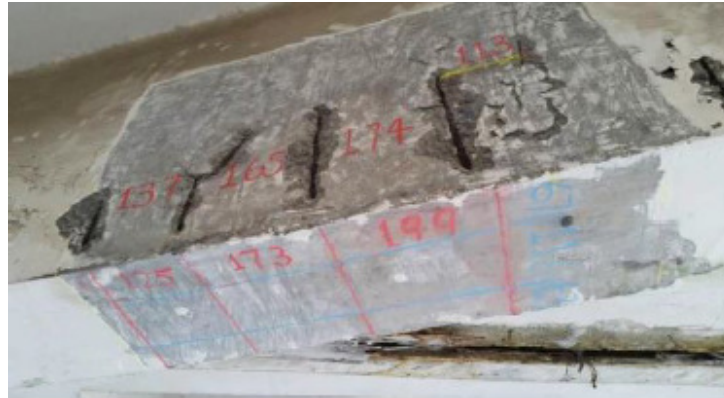
(1) The size of formwork was not the same with design value. In testing zone 2, the width of beam should be 250 mm, but the measurement width was 246 mm. In testing zone 3, the width of beam should be 400 mm, but the measurement width was 396 mm. The size of formwork was smaller than design, if the size of rebar cage was the same with design value, the thickness of concrete cover would be thin. Just like testing zone 2 (Figure 7), the concrete cover on the surface of stirrup was too thin, what caused the stirrup rusted seriously and even exposed.

Figure 7. Measurement of formwork size in testing zone 2.

(3) As a means of increasing level of durability, the size of formwork should be controlled accurately. The strength and stiffness of formwork should be increased and the size of reinforcement cage should be controlled accurately. What calls for special attention is that the thickness of concrete cover should be controlled accurately.

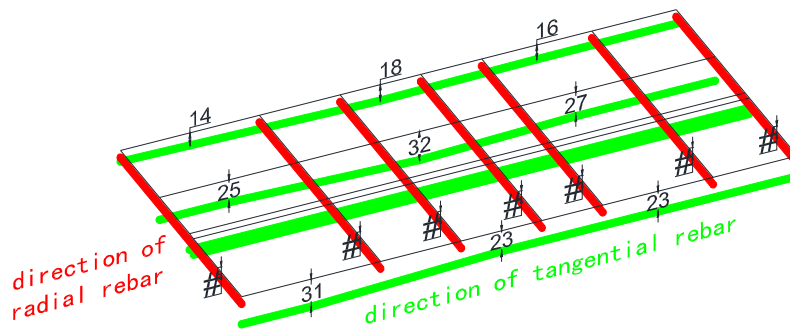
different from design. In this testing zone, some rebar was exposed and some concrete cover was too thin.

Figure 9. 3D diagram of concrete cover in testing zone 3 (mm).
